**ASBESTOS SURVEY INVENTORY
ANNETTE ISLAND STATION
ANNETTE ISLAND, ALASKA**

**FEDERAL AVIATION ADMINISTRATION
NATIONAL HEADQUARTERS
AIRWAY FACILITIES DIVISION ANS-510
800 INDEPENDENCE AVENUE, SW
WASHINGTON, DC 20591**

DECEMBER 12, 1994

**RESEARCH MANAGEMENT CONSULTANTS INC.
ENVIRONMENTAL ENGINEERING DIVISION
3190 S. WADSWORTH BLVD., SUITE 100
LAKEWOOD, COLORADO 80227
(303) 969-8778**

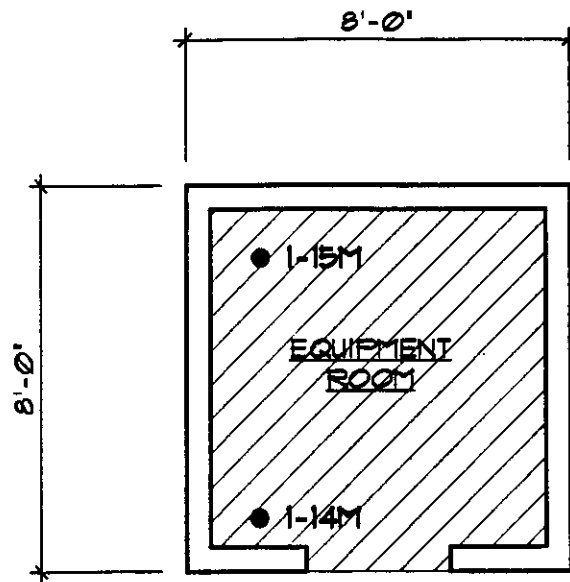
FLOOR PLAN
1/4" = 1'-0"

NOTE:
FIRE DOOR WAS NOT SAMPLED
TO AVOID DAMAGE; ASSUME ACM.

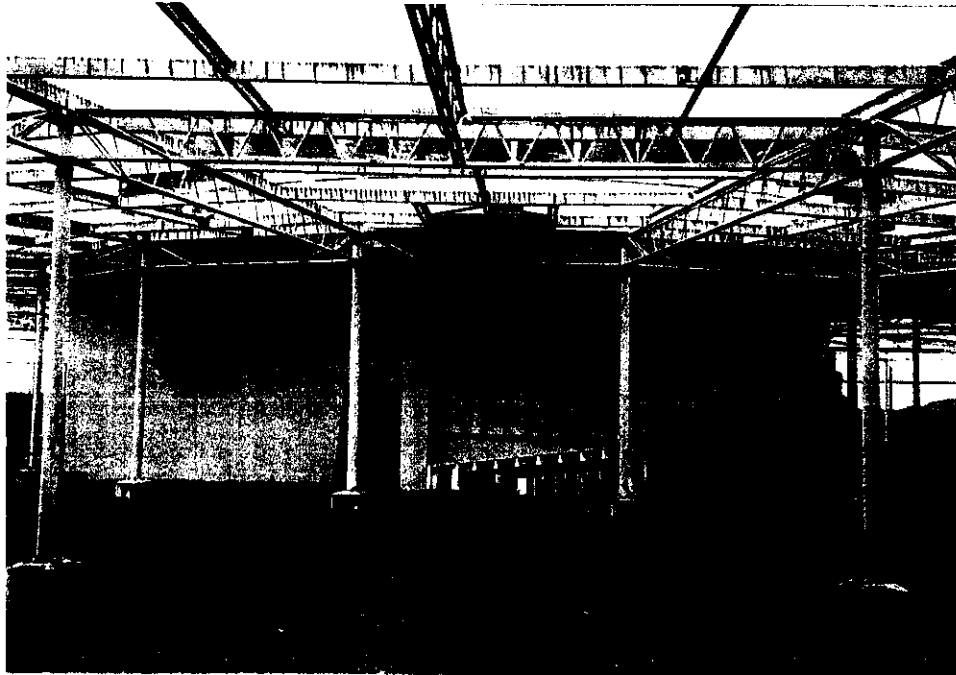
The following ACM was identified at the VOR Building. Unless otherwise noted, the materials were in good condition at the time of inspection (see Data Summary Table - Facility-Specific Inserts):

- Breakroom
 - 284 square feet of non-friable mastic associated with the 1 ft x 1 ft tan floor tile; chrysotile asbestos; the floor tile is non-ACM
 - non-friable drywall joint compound where present on original walls and ceiling; chrysotile asbestos
- EG Room
 - non-friable drywall joint compound where present on original walls and ceiling; chrysotile asbestos
 - non-friable gaskets where present on engine generator; not sampled to avoid damage, assume ACM

1) View of the Annette Island VOR Building (412). August 1994

The following are recommendations for ACM identified at the VOR Building. Materials assumed asbestos-containing should be sampled by trained personnel and analyzed by an accredited laboratory prior to removal or alteration. Unless planned renovations, repairs, damaged ACM, or the potential for damage require such actions, it is recommended that the ACM identified in this report not be disturbed or removed. If the ACM must be disturbed or removed for any reason, personal protective equipment and properly trained personnel must be utilized. Alterations to or the removal of asbestos-containing materials requires adherence to all applicable federal, state, and local regulations concerning the removal and disposal of asbestos materials. Periodic condition inspections are recommended until the materials are removed.

Fire doors are classified as non-friable as long as the veneer of the doors remains intact and undisturbed. The insulation located at the core of a fire door is classified as friable. If the door veneer is cut, drilled, or penetrated in any manner, asbestos fibers could be released. Fire doors are normally identified by the fire-rating labels adhered to the doors. Because the labels are not always present, some fire doors may not be identified. The fire doors in this facility were not sampled to avoid administering damage and are assumed to be asbestos-containing. Therefore, prior to cutting, drilling, or in any way penetrating any of these doors, the insulation should be sampled and analyzed for asbestos content.

Floor tiles and associated mastics are classified as non-friable materials. These materials can become friable when in severely damaged and/or dry conditions. Care should be exercised when cleaning floor tile surfaces. A wet cleaning or polishing agent should always be used when buffing is performed. Abrasive actions, such as dry buffing, drilling, grinding, hammering, sawing, etc., should not be performed unless proper precautions are followed. For abatement purposes only, non-asbestos-containing floor tile is considered cross-contaminated by its asbestos-containing mastic.

Drywall joint compounds are classified as non-friable in a finished and painted state. Penetrations of these materials will cause them to become friable. Abrasive actions, such as sanding, drilling, cutting, etc., should be prohibited unless proper precautions are observed.

Gasket materials are generally classified as non-friable materials; however, when exposed to heat for extended periods of time, they will become dry and brittle, and therefore, be considered friable. Abrasive actions, such as cutting, tearing, grinding, etc., may also cause the materials to become friable and should not be performed on these materials unless proper precautions are followed. Gasket materials are typically located between two separate flat surfaces and, except for the edges, are rarely visible. The only time these materials are exposed is when maintenance procedures require their removal or repair. The gaskets on the engine generator at this facility were not sampled to avoid damage and are assumed to be asbestos-containing.

Roofing materials are classified as non-friable unless severely damaged by heat, air, or water erosion. Generally, if roofing materials are damaged to the extent that they are considered friable, the roofing system will fail and replacement will be necessary. Abrasive actions, such as cutting, drilling, grinding, etc., should not be performed on asbestos-containing roofing materials. Roofing materials identified as suspect, but that were not sampled are assumed to be asbestos-containing and should be core-sampled prior to the performance of any maintenance or replacement procedures. The VOR Building roof was inaccessible for inspection due to equipment in use, assume ACM.

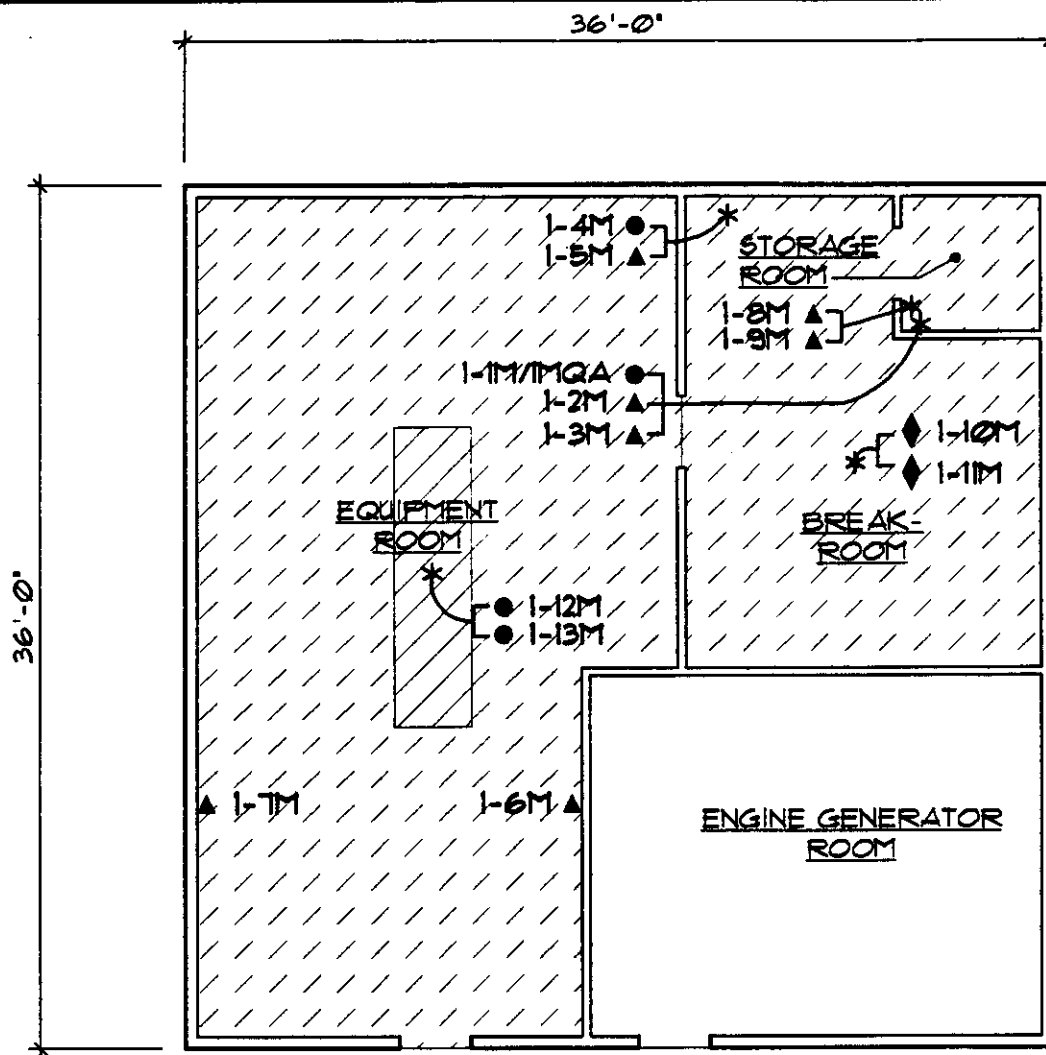
FLOOR PLAN

ALL FIRE DOORS THROUGHOUT THIS FACILITY WERE NOT SAMPLED TO AVOID DAMAGE; ASSUME ACM.

- GASKETS ON ENGINE GENERATOR; NOT SAMPLED TO AVOID DAMAGE; ASSUME ACM.
